In better nick than we'd hoped

Close inspection of the Yamaha twin's engine internals reveals a relatively happy state of affairs for spannerman Rod Gibson.

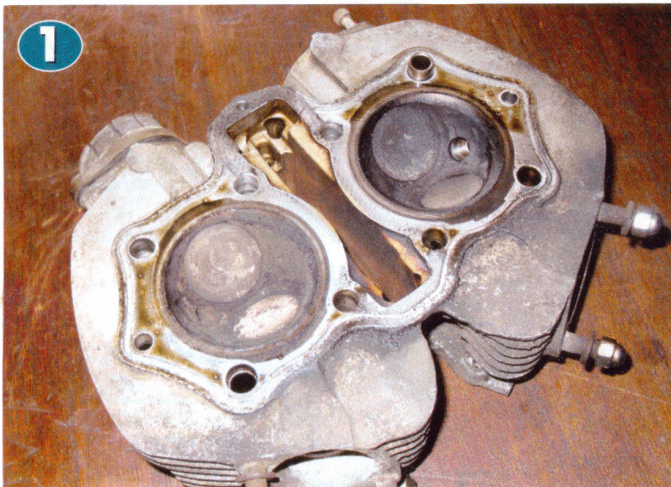
Picture one: With the cylinder head off the combustion chambers show signs of heavy carbon deposits, particularly on the left cylinder. This looks dry, rather than oily, and leads me to wonder if the bike had been running too rich. Before cleaning up the combustion chambers I'll take a closer look at the pistons.

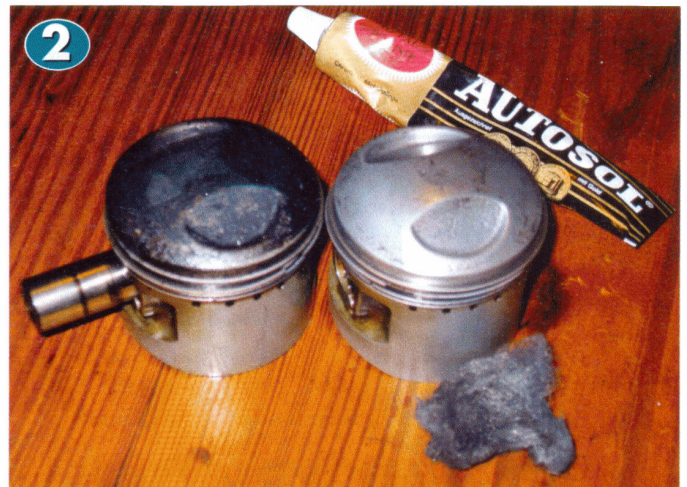
Picture two: The piston crowns also have heavy carbon deposits but otherwise look in fairly good shape. A few minutes work with some steel wool and Solvol Autosol reveals shiny alloy beneath. The pistons are standard, indicating that the bike has not yet been re-bored. This gives plenty of scope for reconditioning if required.

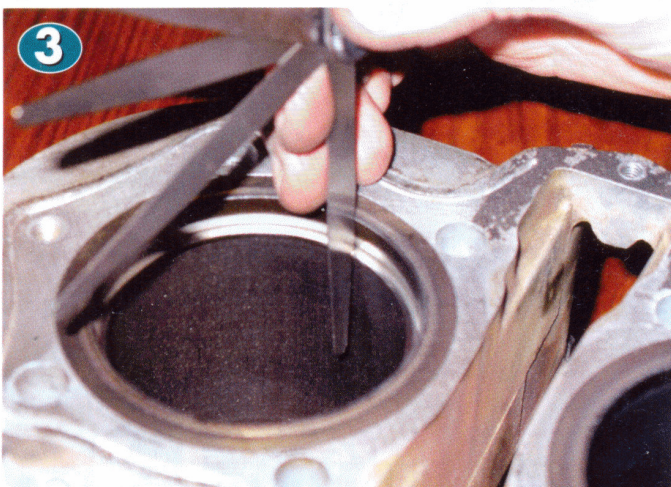
Picture three: The ring gap measurements are well within factory tolerances. I always measure the gaps at both the top and the bottom of the stroke. No wear ever occurs at the bottom of the cylinder bore so an excessive gap here gives a measure of piston ring wear.

Any wear on the bore itself will be at the top of the stroke; if the ring gap is appreciably larger here a re-bore might be necessary to recondition the bores. These simple measurements give a quick and

accurate indication of both bore and ring condition.

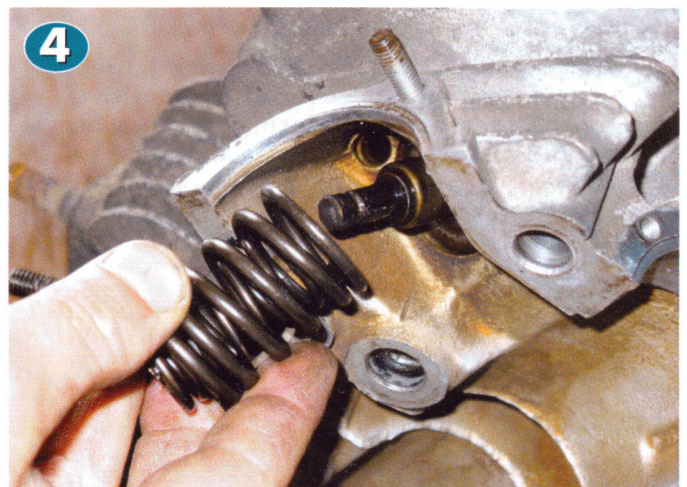
Picture four: Satisfied that the bores and piston rings are serviceable, I can now turn my attention to the valve gear. Each valve is retained in place by two split collets engaged into the top valve spring collar.

A valve spring compressor is needed to compress each spring far enough to remove the collets, then the springs can be lifted off and the valves slid downwards out of their guides.
