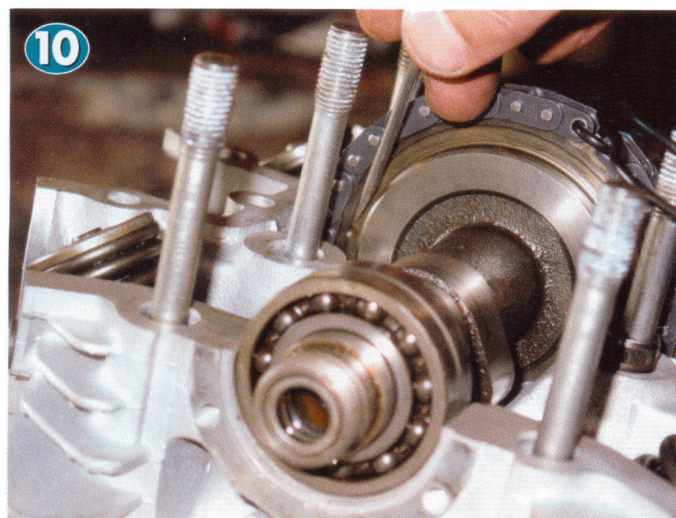
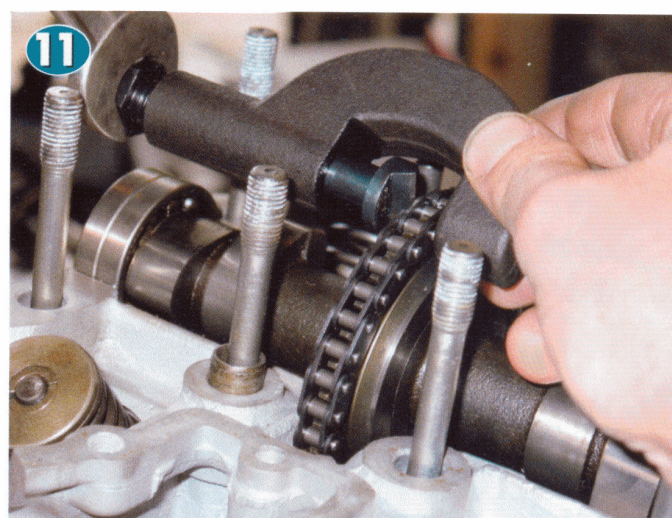
Picture 12: With the camchain tensioner refitted to the rear of the cylinder block I can now tension up the chain. On this design the threaded sleeve winds down around the plunger until the plunger end is flush with the housing. This correctly pre-loads the tensioner spring. The new camchain was quite a tight fit

so I've set the tensioner up with almost zero pre-load for the time being. It will need checking once the engine has run.

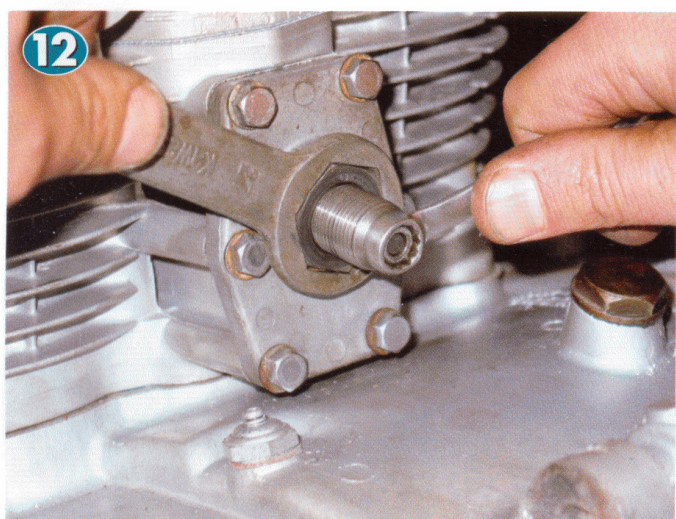
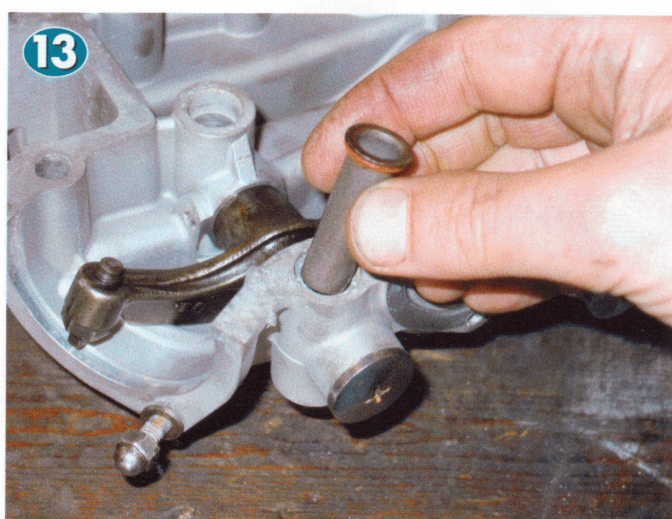
Picture 13: Next, the rocker cover. I've already refitted the rocker arms but these four sleeves need to be pressed into place with new O-rings before fitting the cover. The

sleeves and O-rings will prevent oil leaking out past the head bolts. A thin smear of Blue Hylomar will seal the rocker cover to the cylinder head.

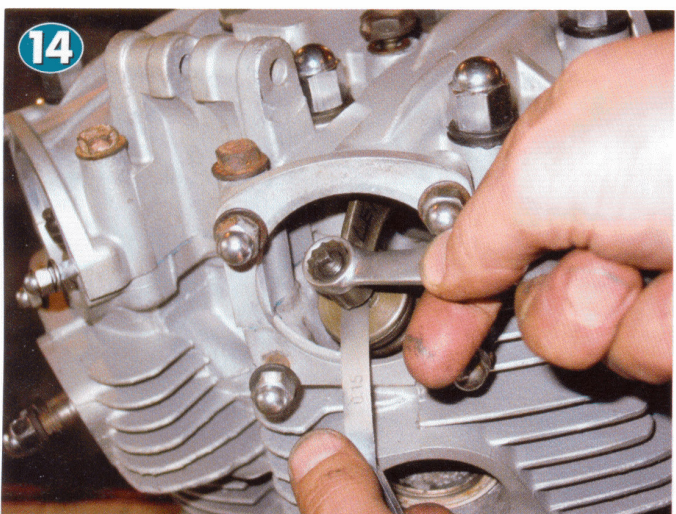
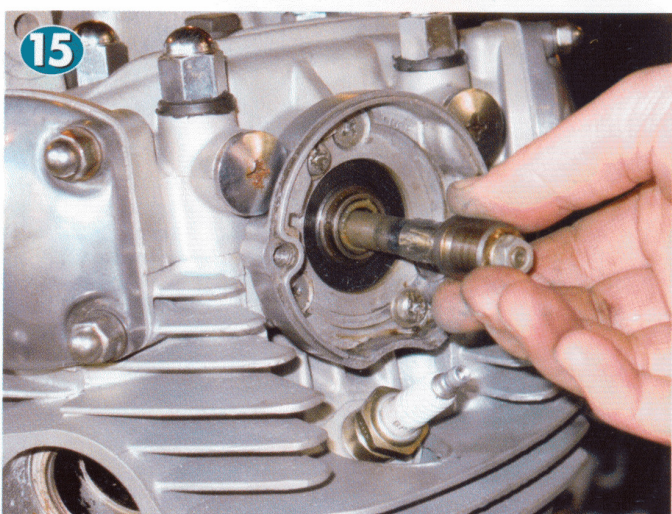
Picture 14: This is a convenient time to set the valve clearances. These could close up slightly once the engine has started up so I'm
