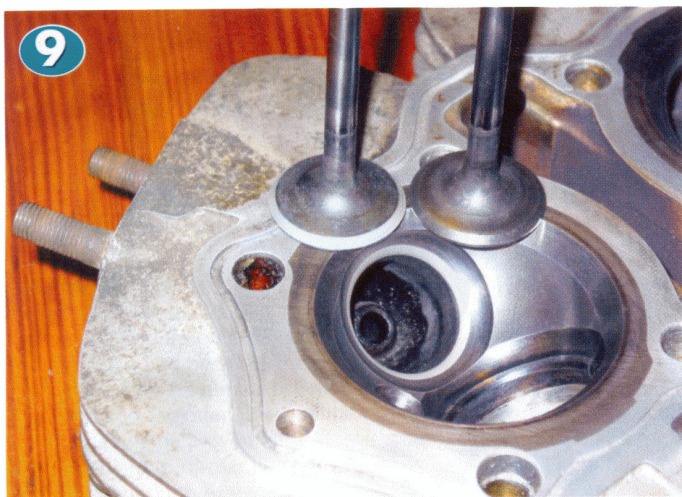
Picture 13: Before the valves go back in these valve stem seals need to be replaced. They just pop over the tops of the guides and serve to stop excess oil running down the guides which would cause the engine to

smoke on the over-run. Replace them every time they are disturbed.

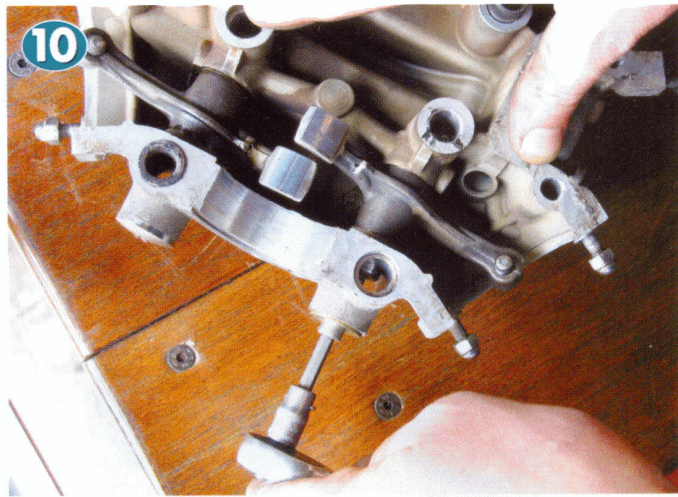
Picture 14: Now the valves can be re-fitted in their original positions. The valve spring compressor allows me to hold the valve springs down whilst popping the split collets into place on the valve stem. A smear of grease holds them in place while I unwind the compressor and remove it. Don't forget the steel washers under the valve springs.
